Pictures from a realistic full-scale fire test with two passenger cars and a HRR of 12 MW in the B260 Malberg tunnel at Bad Ems, Germany, on 27th of Sept. 2006

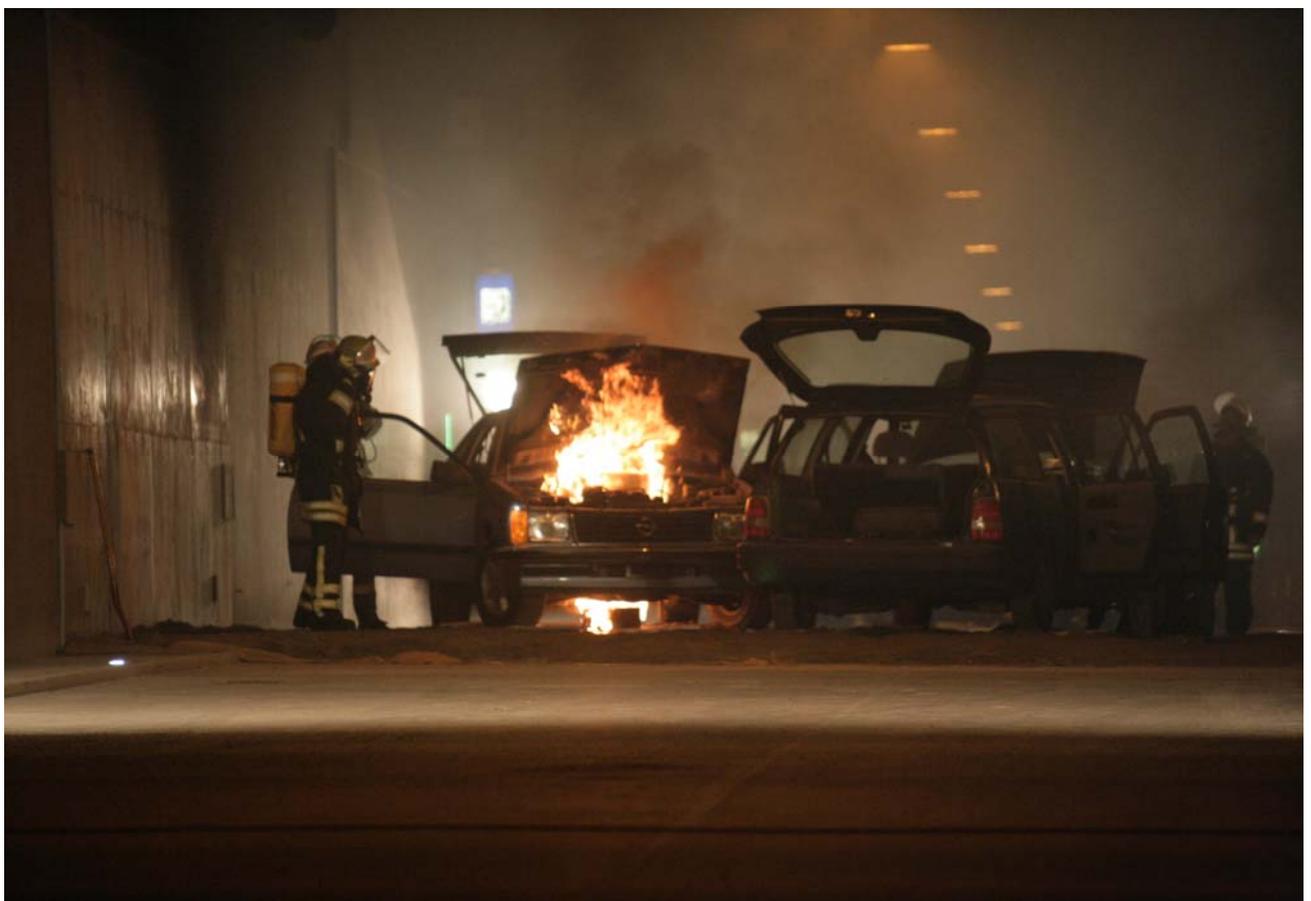
Picture 24: The start of the fire in the fire box (ignited by a torch) created a slight plume of smoke, when viewed from the east.

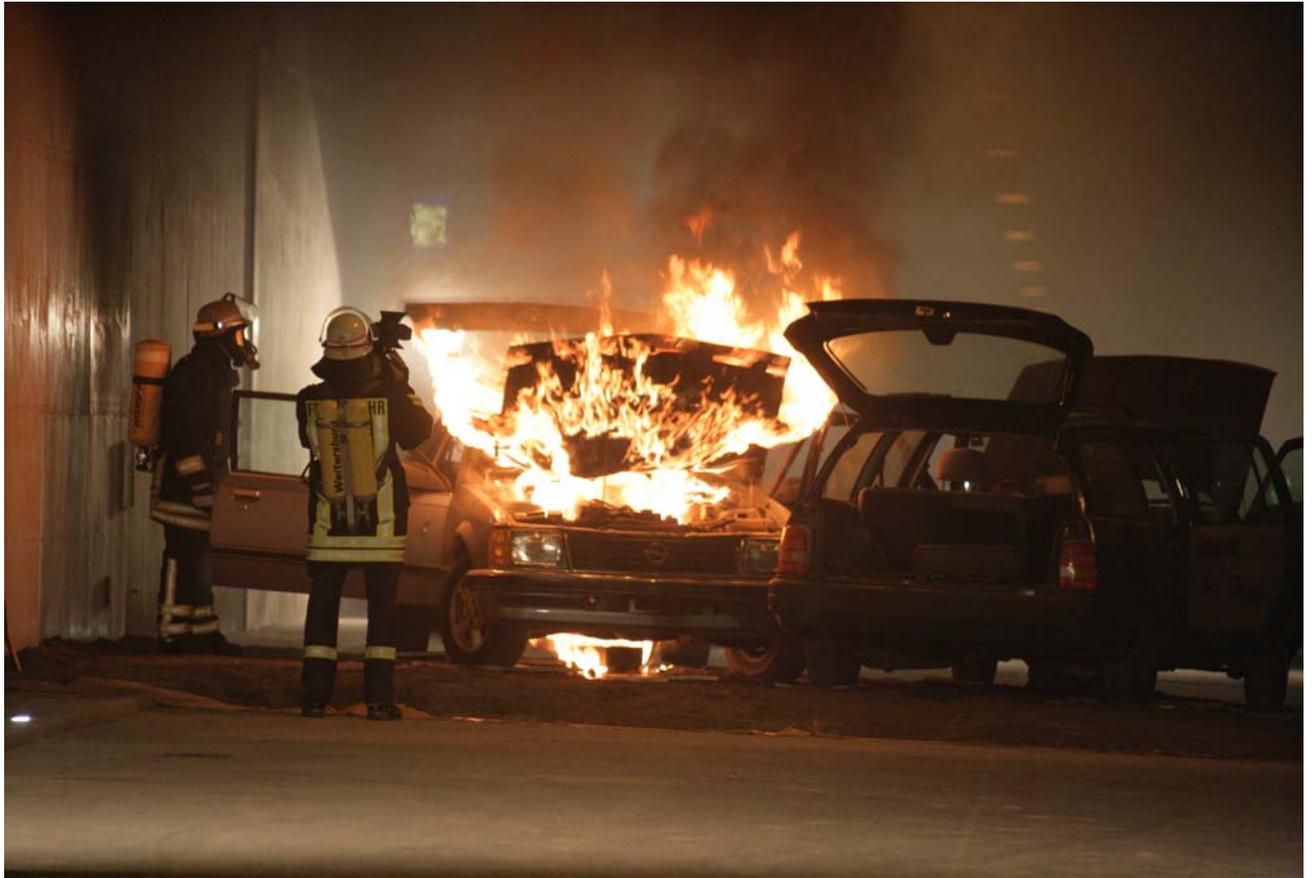
Picture 25: The developing of the fire in the engine compartment (the batteries have been removed in advance) with slight dimming of the ceiling lights, viewed after 4 minutes from the east.

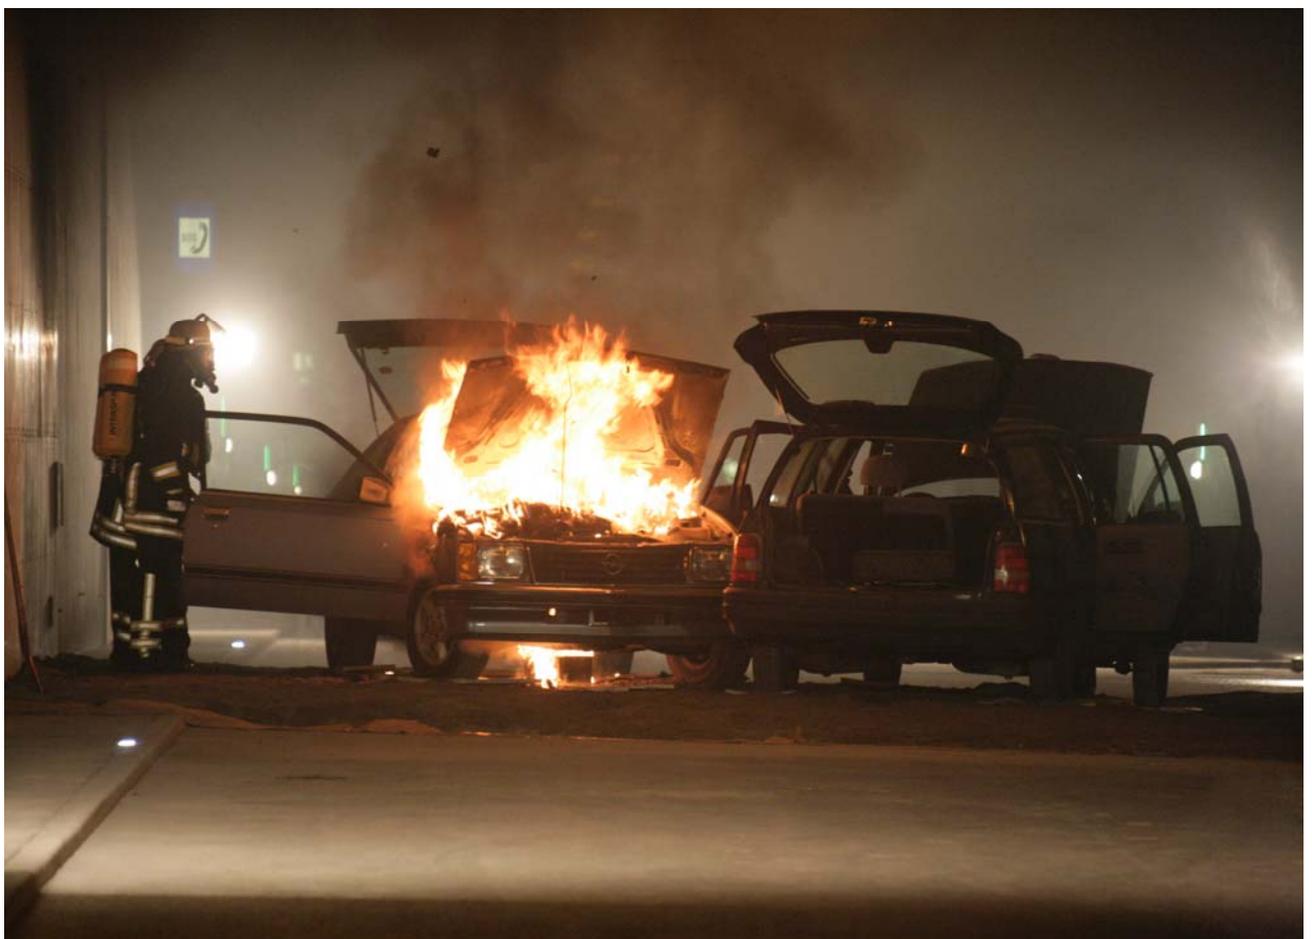
Picture 26: The fire viewed after 5 minutes from the east, when the ceiling lights were heavily dimmed.

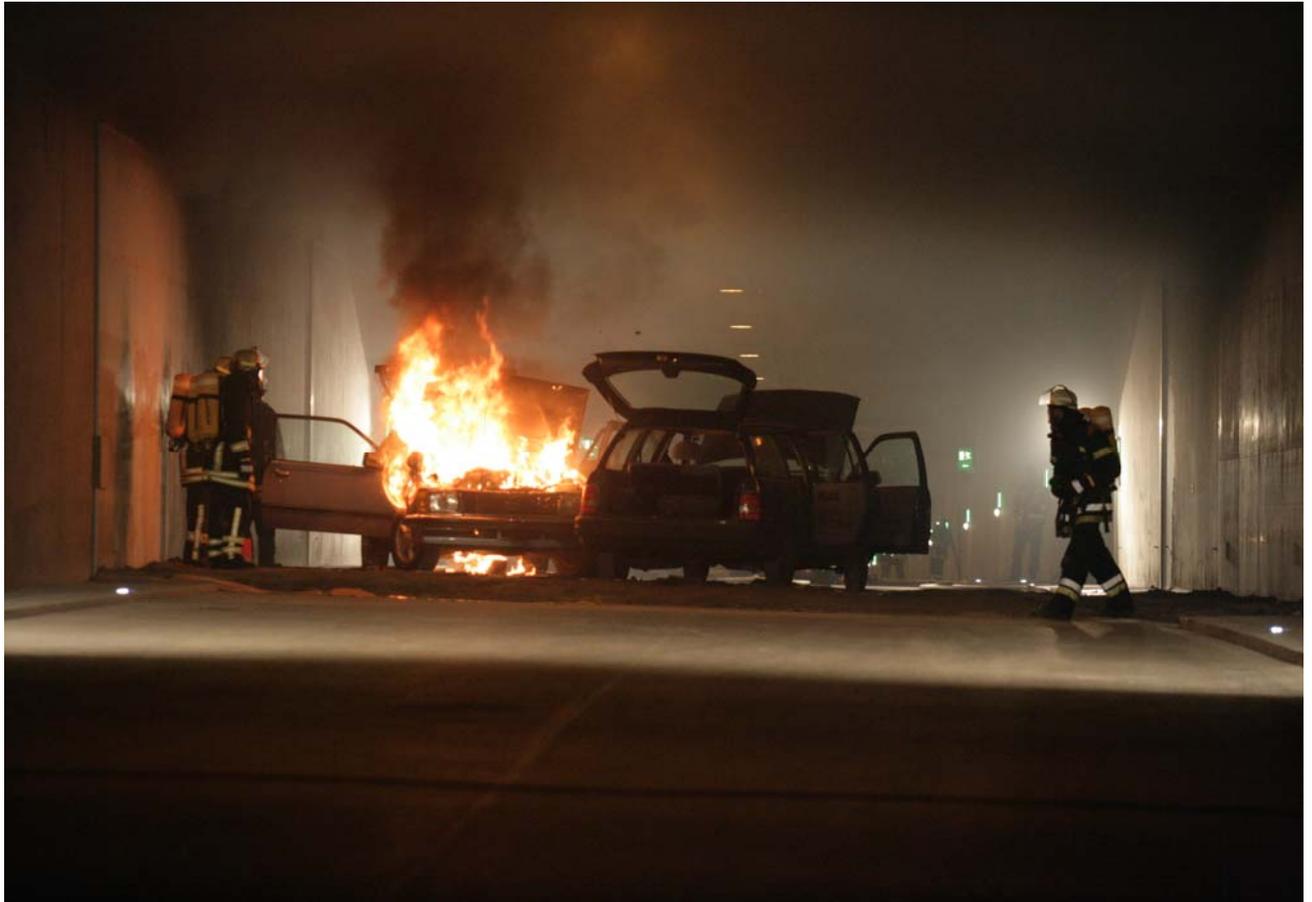
Picture 27: The fire viewed after 6 minutes from the east, when the ceiling lights were totally dimmed.

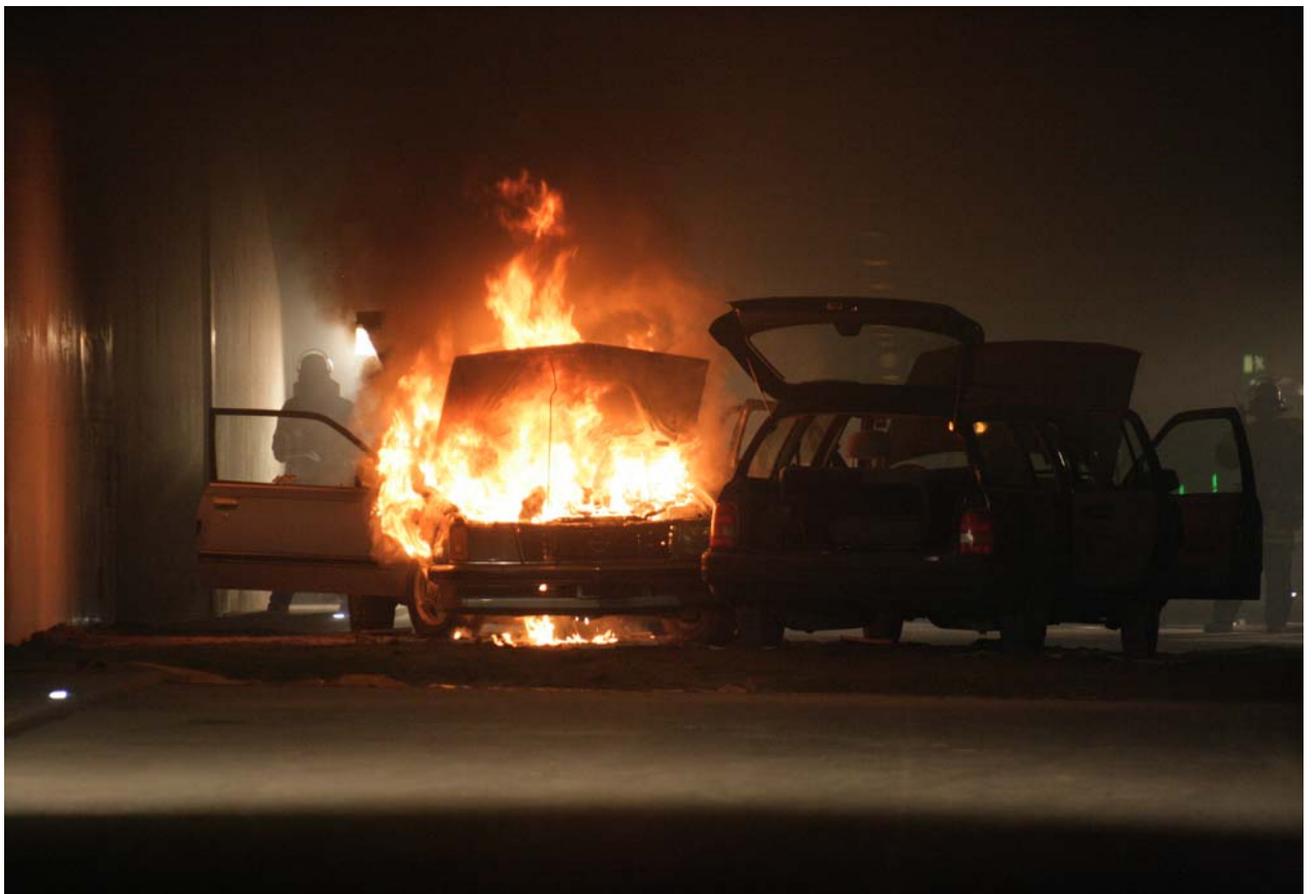
Picture 28: The fire viewed after 8 minutes from the east, when the plume and the smoke layer grew up.

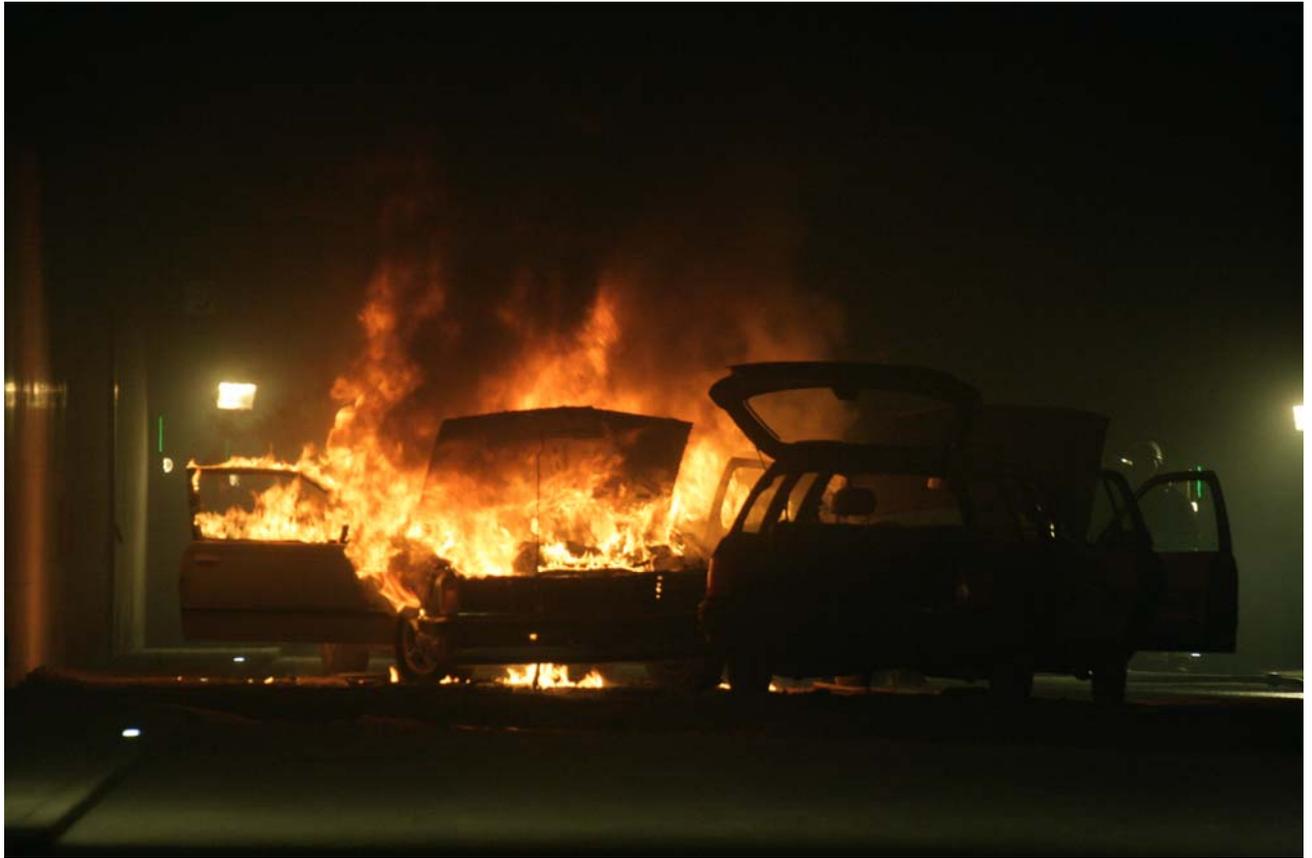
Picture 29: The fire viewed after 10 minutes, when the smoke layer was still stable and darkening the entire division of the tunnel between the two smoke extracting stations #05 and #06.

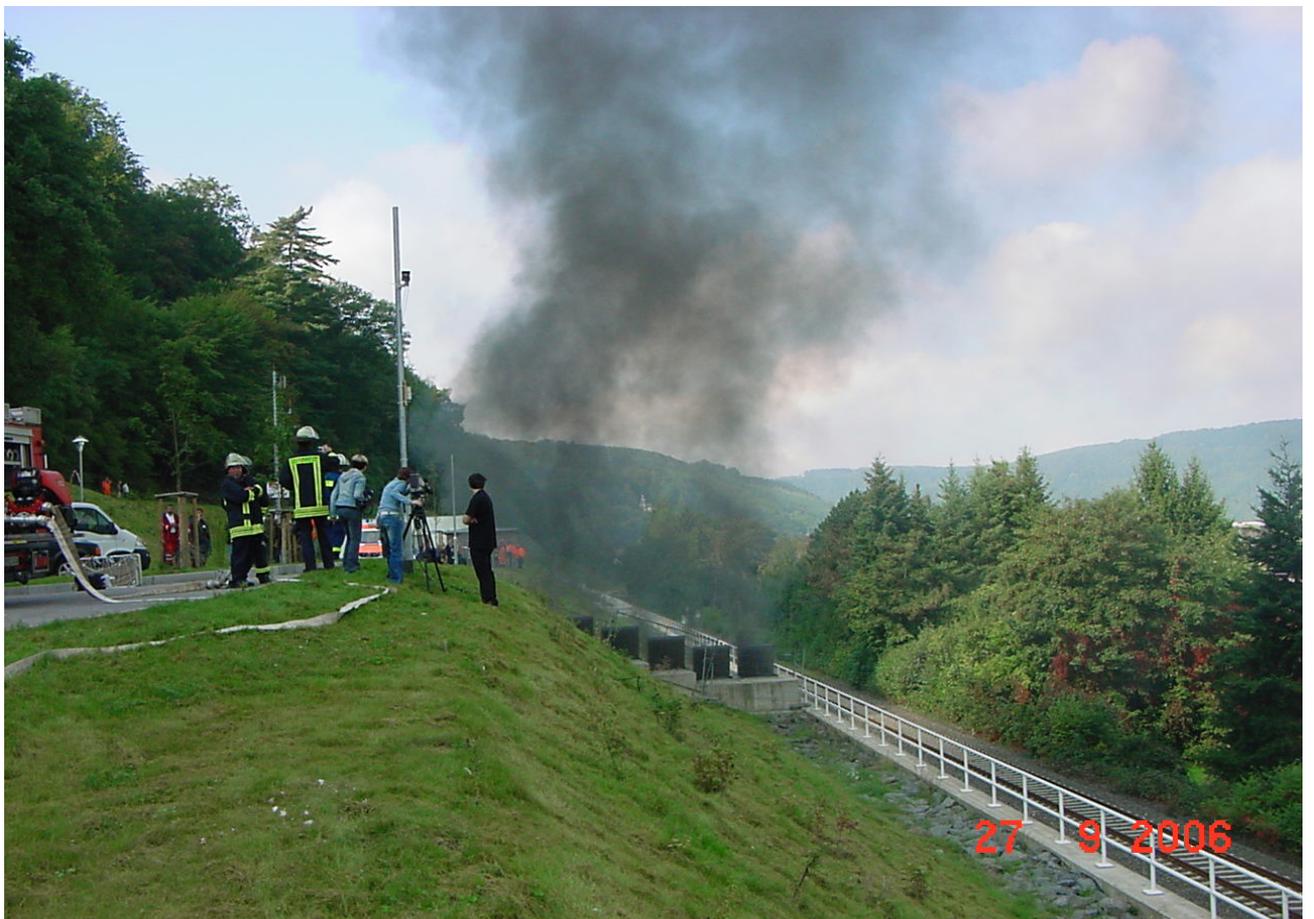
Picture 33: The clouds of smoke were discharged from the smoke exhaust shafts #05 and #06 (both were at nearest to the fire place), viewed after 22 minutes from the east.

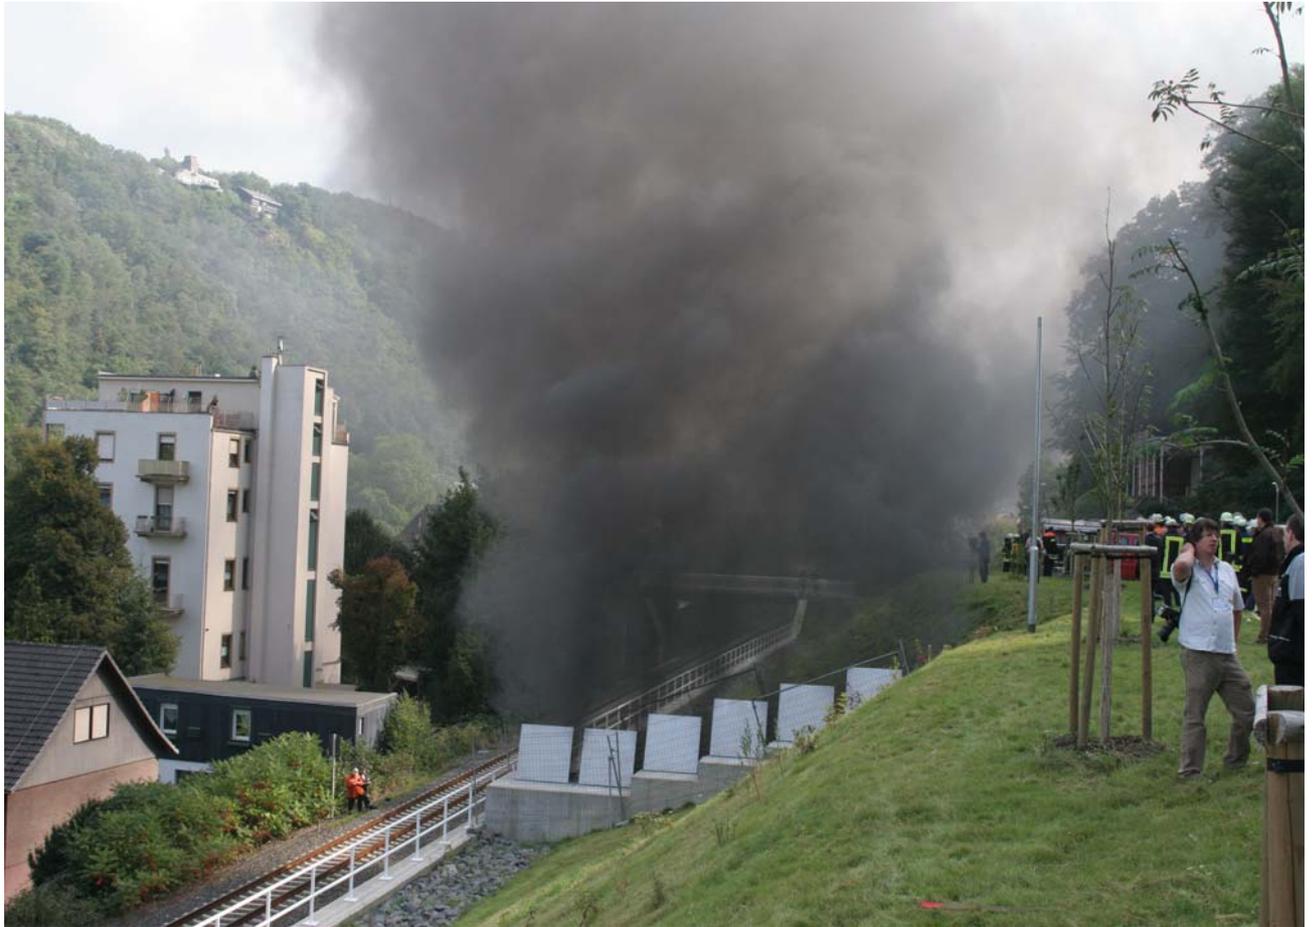
Picture 34: The smoke discharge from the exhaust shaft #05, viewed after 23 minutes from the east.

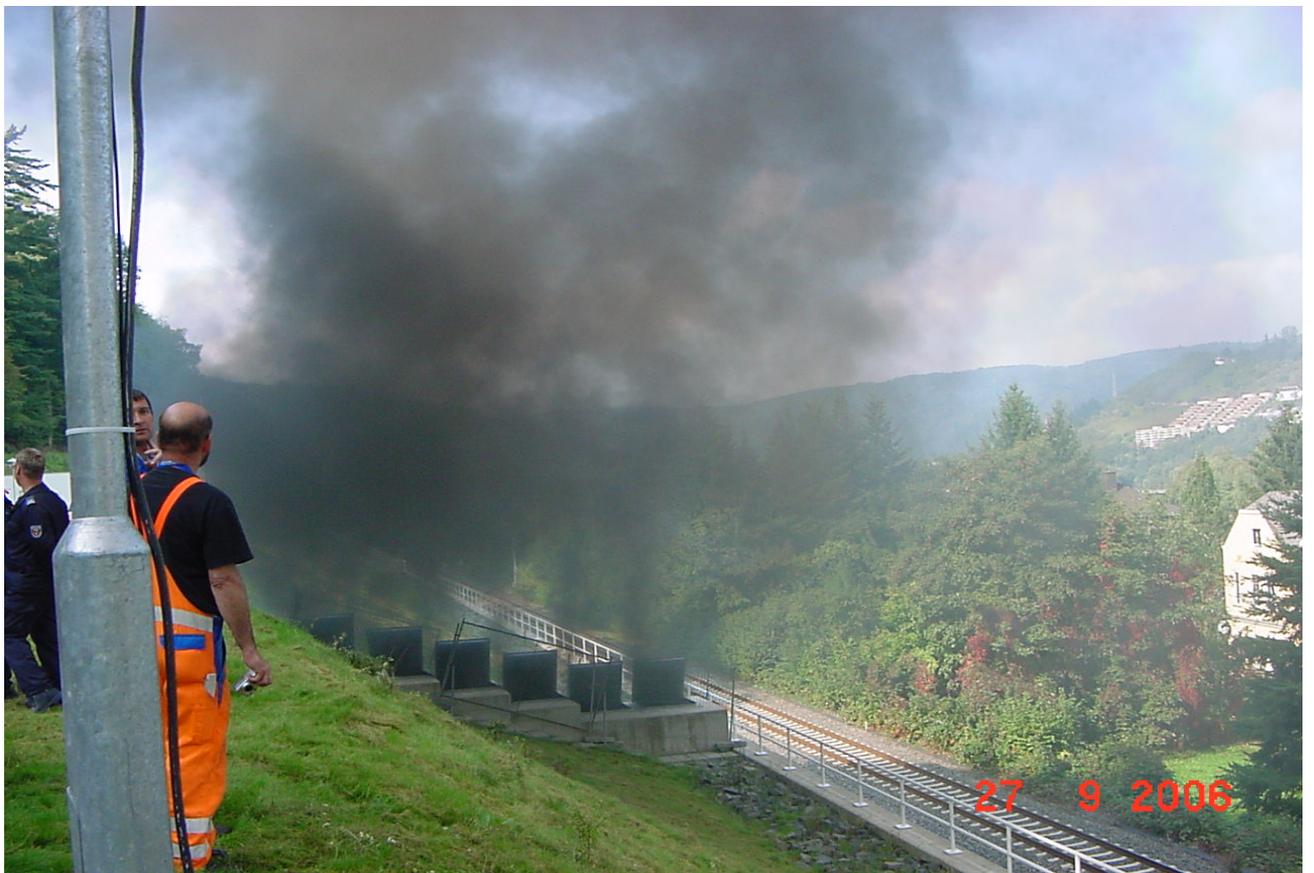
Picture 35: The plume of the smoke reached a height of about 25 m above the discharge openings of the exhaust station #05 (at minor wind influence), viewed after 23 minutes from the west.

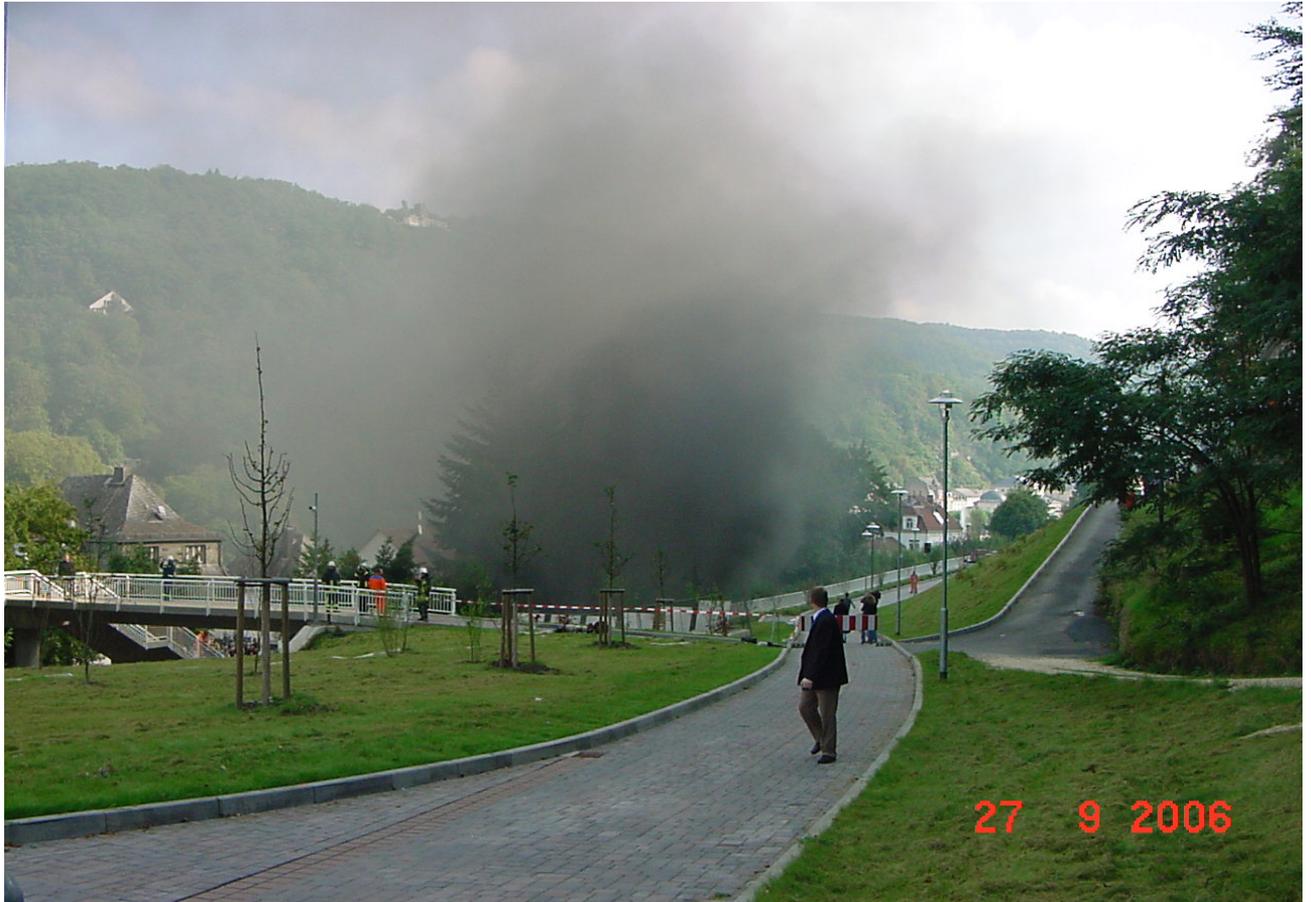
Picture 36: The smoke as discharged from exhaust station #05, viewed after 28 minutes from the east.

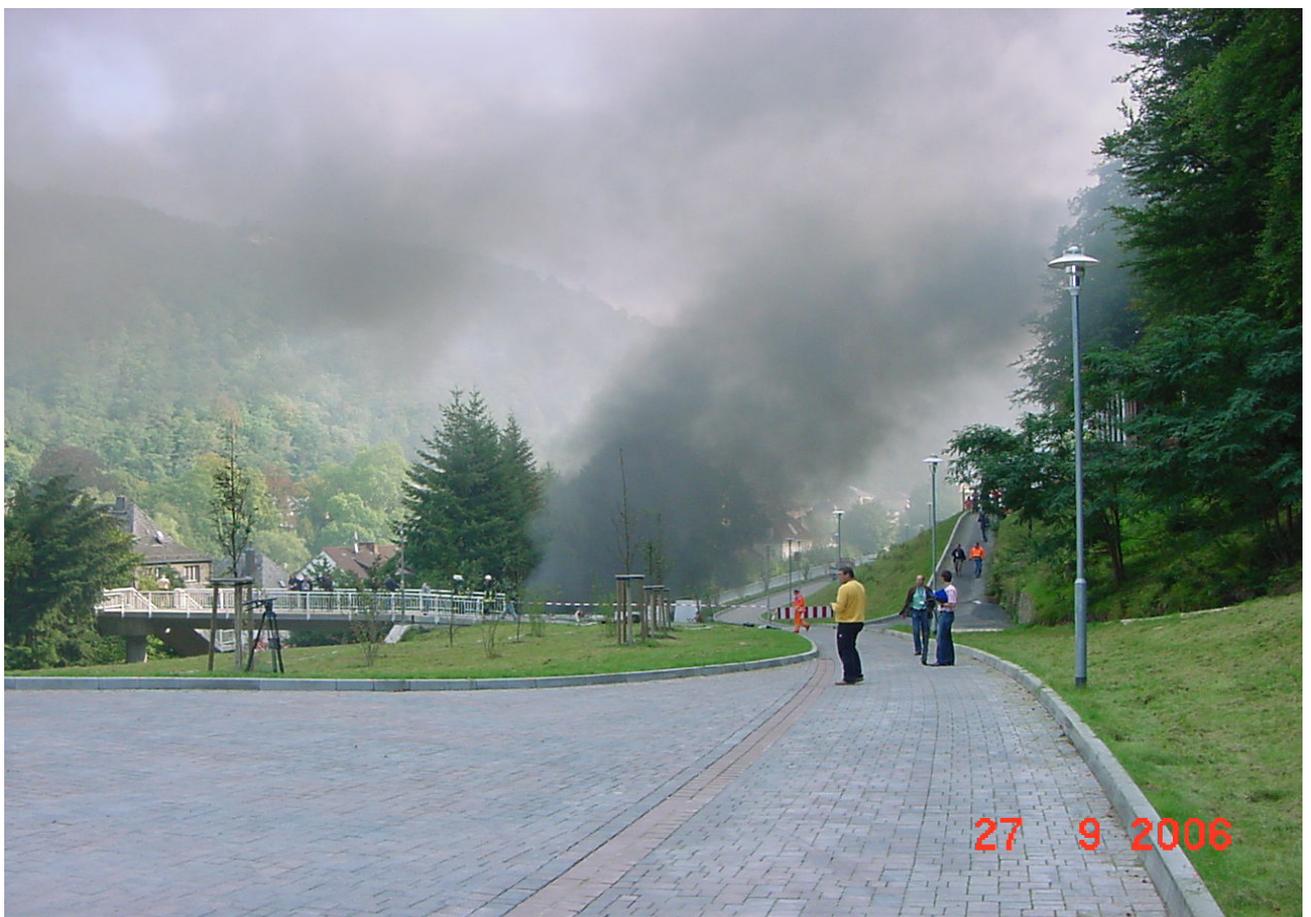
Picture 37: The smoke as discharged from exhaust station #06, viewed after 23 minutes from the west.

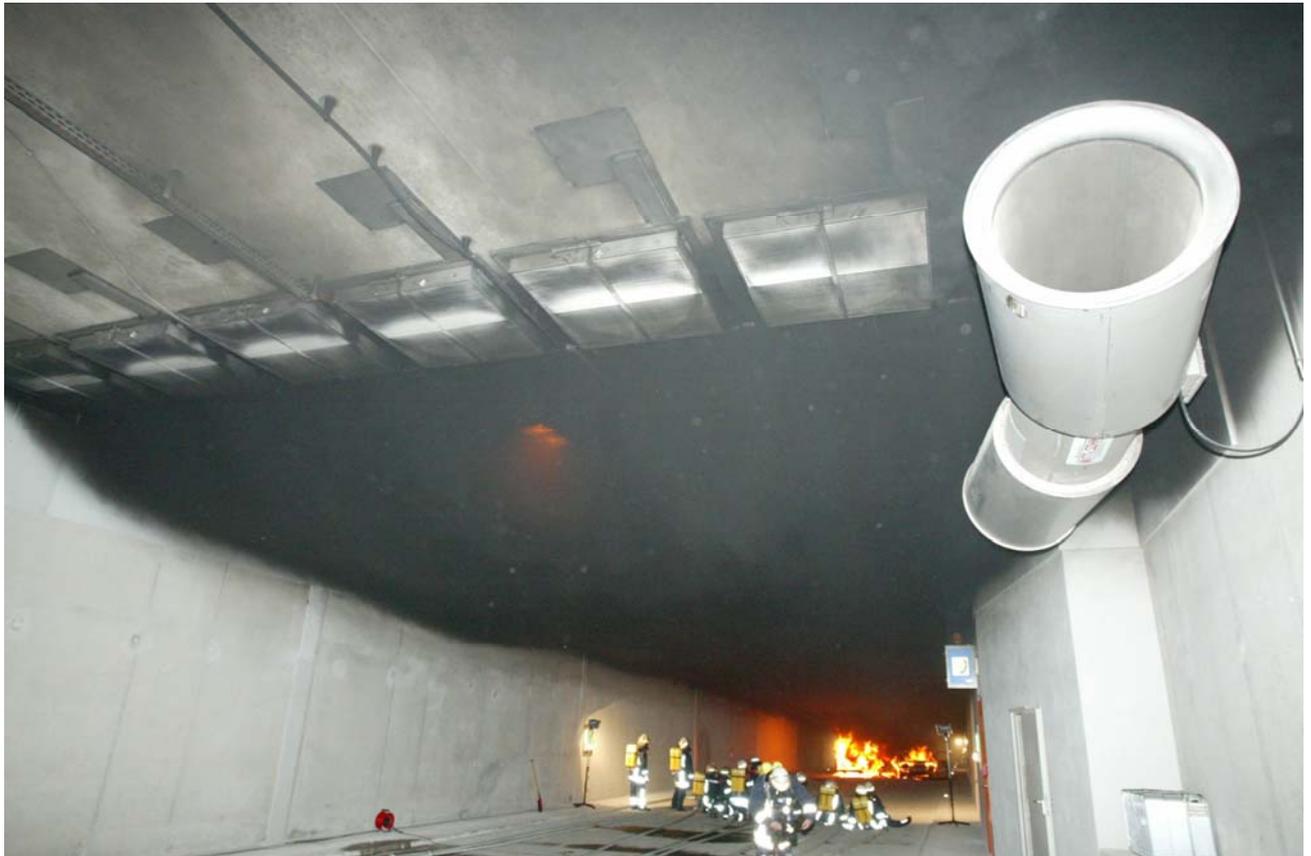
Picture 40: The stable flow pattern of the smoke layer below the ceiling heading towards the extracting station #06, viewed after 12 minutes from the east, all escape routes, emergency walkways and stair cases were kept free from smoke over the entire test period, but ceiling lights were darkened and cameras went blind so that no useful video image from near the fire place was available in the control room.

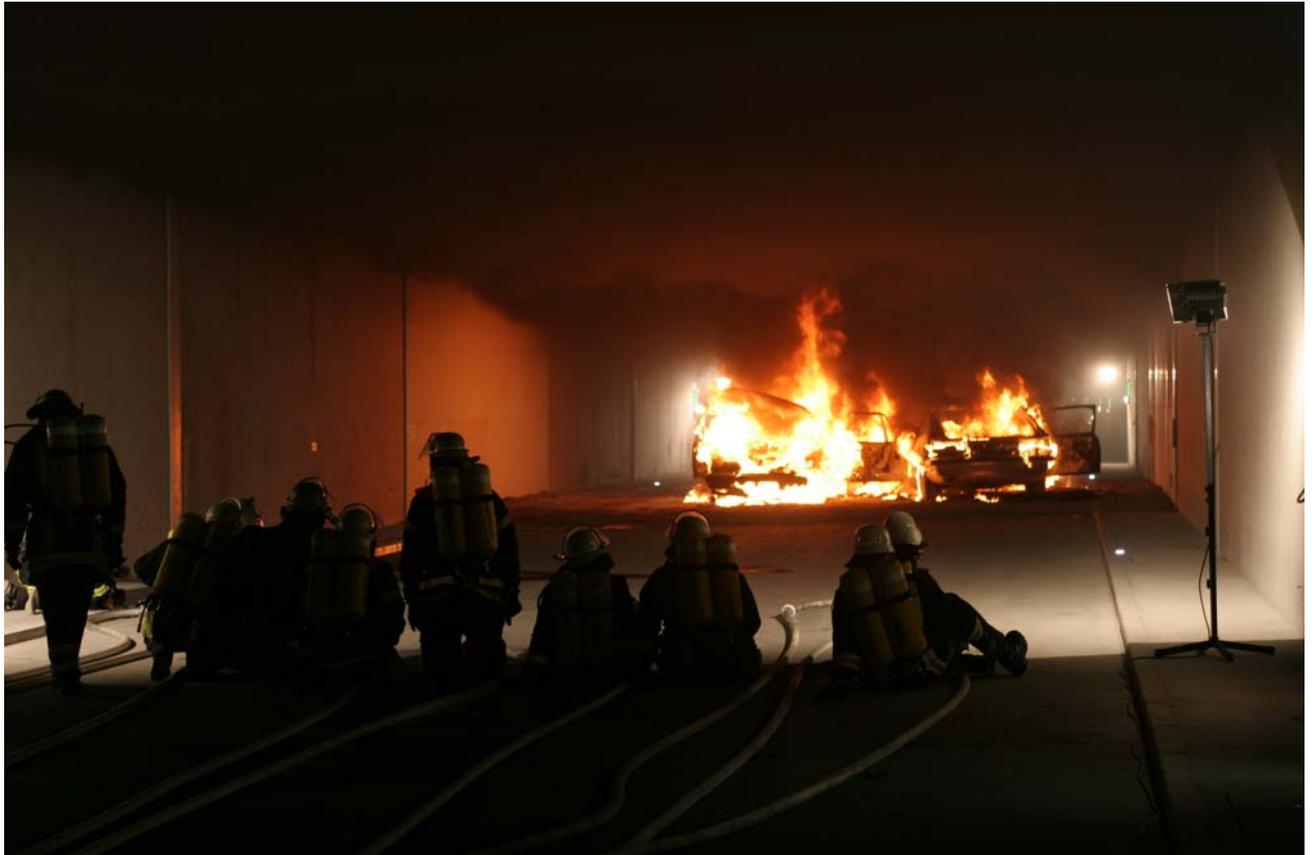
Picture 42: There was a maximum HRR of 12 MW from the burning cars, viewed after 24 minutes from the west, and still there was a stable smoke layer as the fire brigade organised for the near attack.

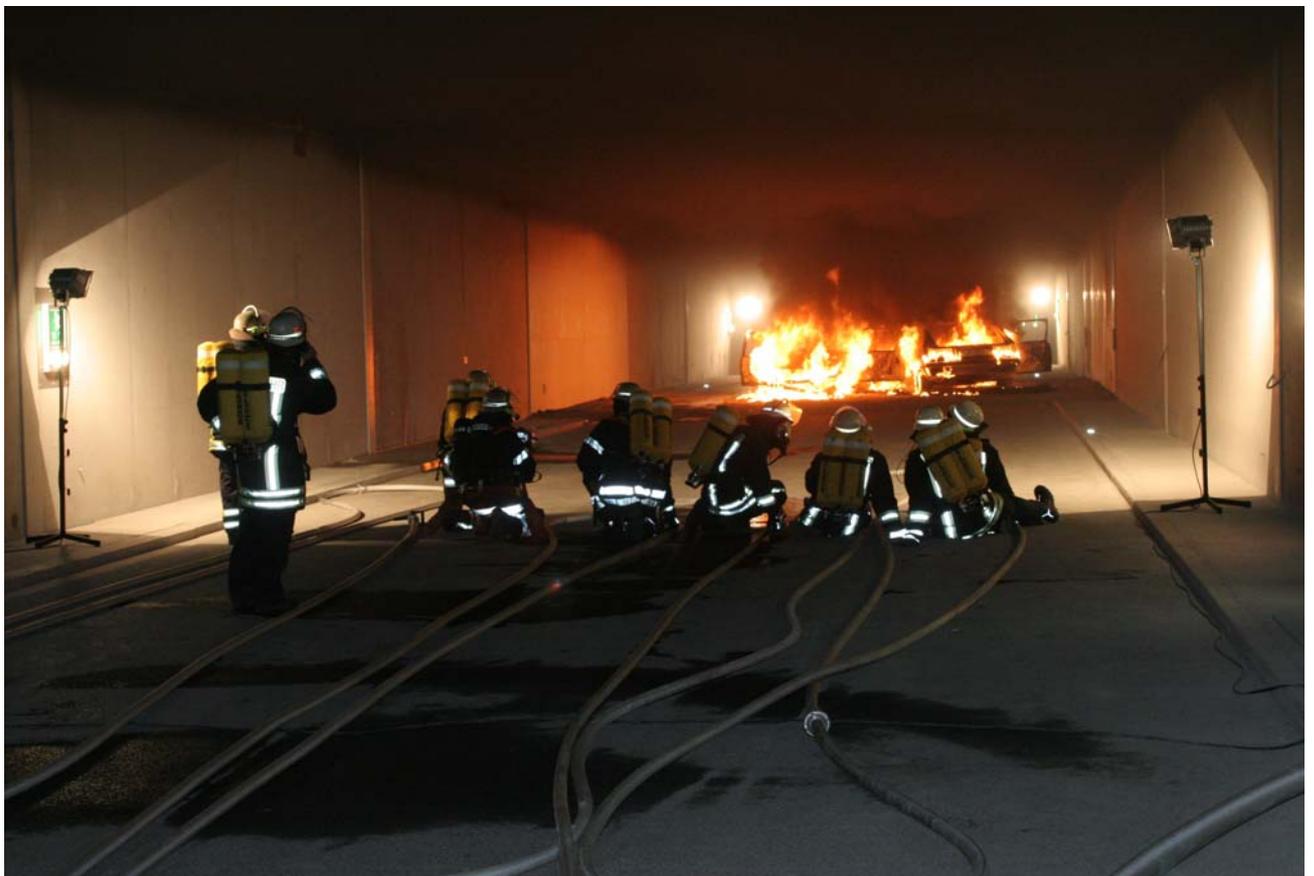
Picture 43: The cars were still burning, viewed after 26 minutes from the west and lighted by 4 floodlights, when the fire brigade observed the ongoing fire in a distance of 20 m, ready to fight it.

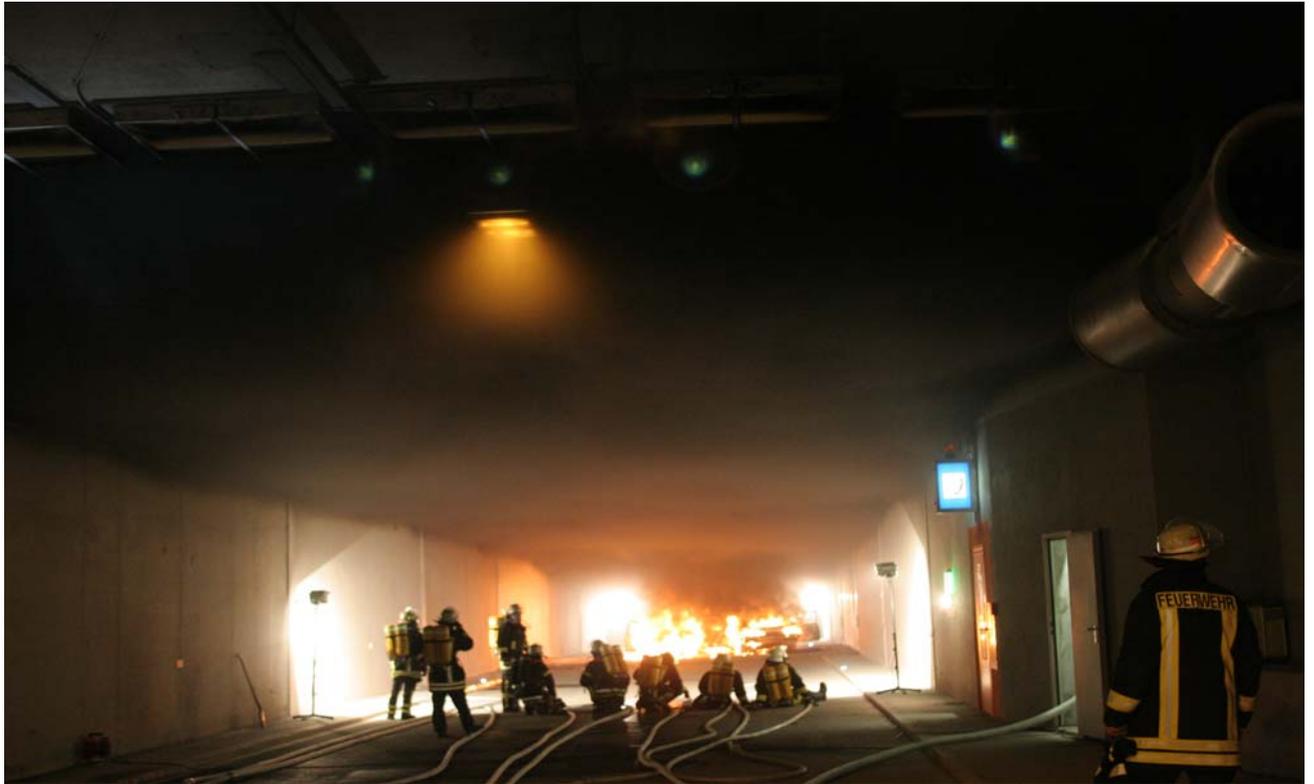
Picture 44: The cars were still burning, viewed after 27 minutes from the west, and still there was a stable smoke layer (stratification by density difference) when the fire brigade prepared itself for the attack.

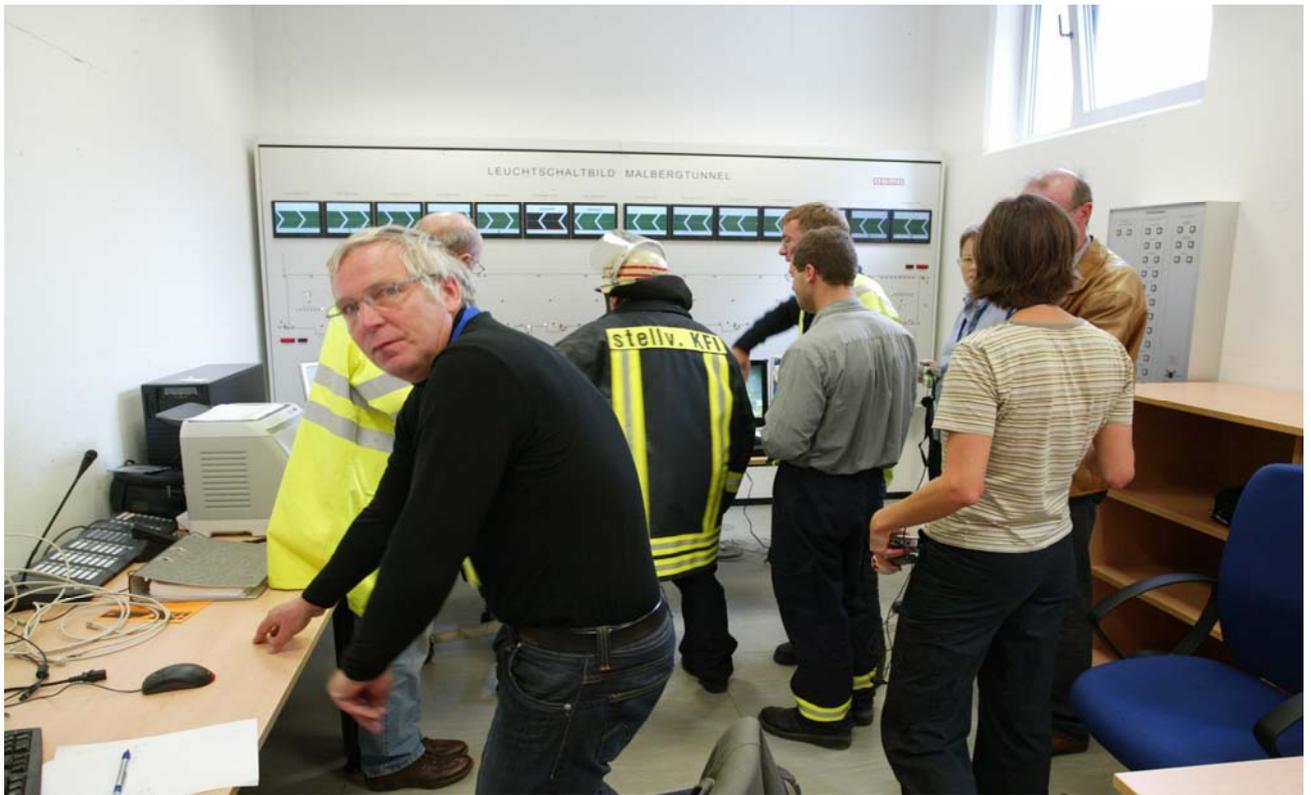
Picture 46: The control room has been furnished with a mimic board on the wall for the indication of the condition of the lighting, ventilation, smoke extraction, alarms, failures and traffic congestions. Video monitors have been placed on the desk next to the process monitors to supervise the traffic flow. Due to the dark smoke the video cameras and monitors went blind and were of no use during the test.

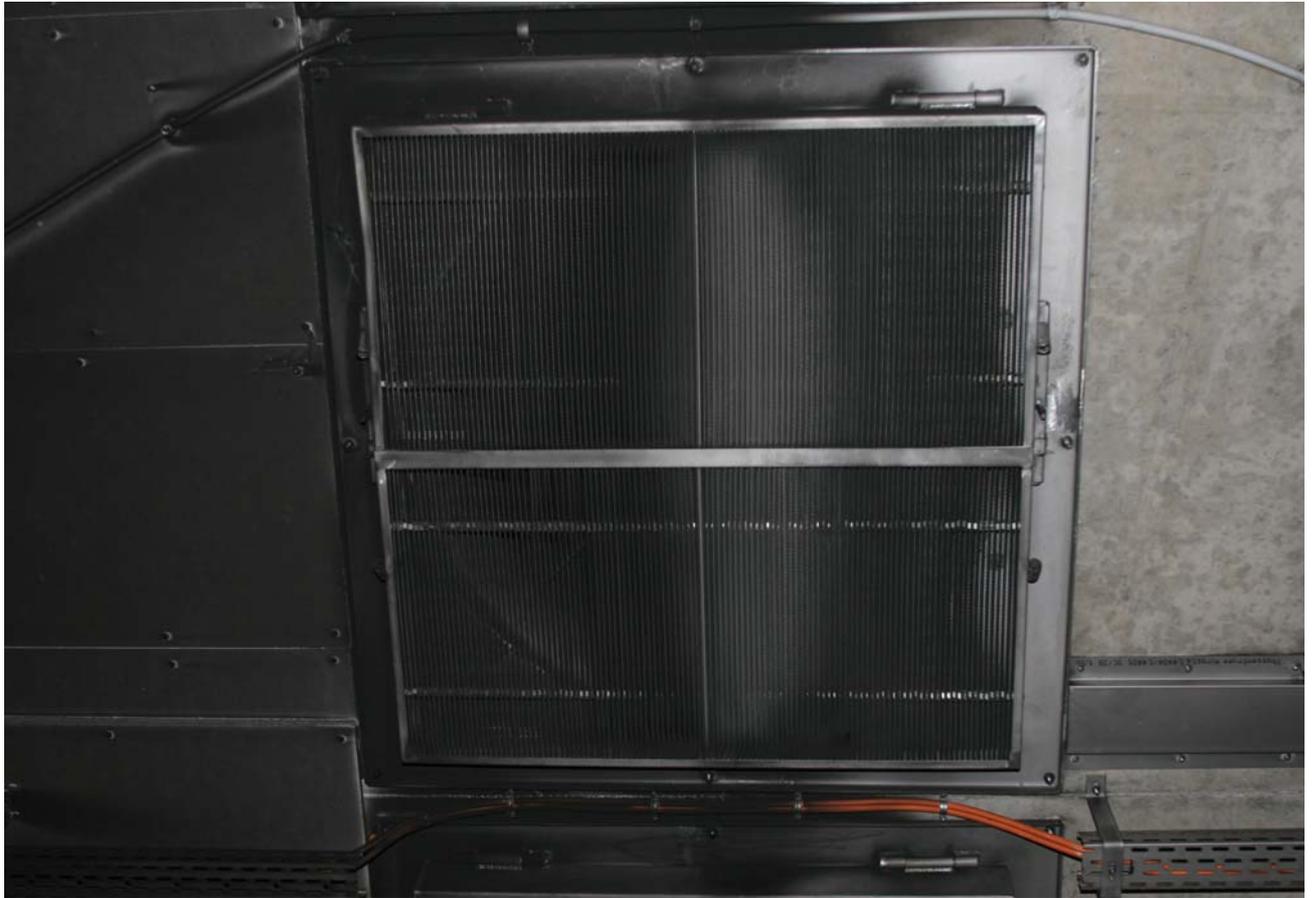
Picture 51: The dampers of the smoke extracting station remained unharmed and have been well functioning after the test (this was the station #06 with dampers, levers and heat insulated gear motors).

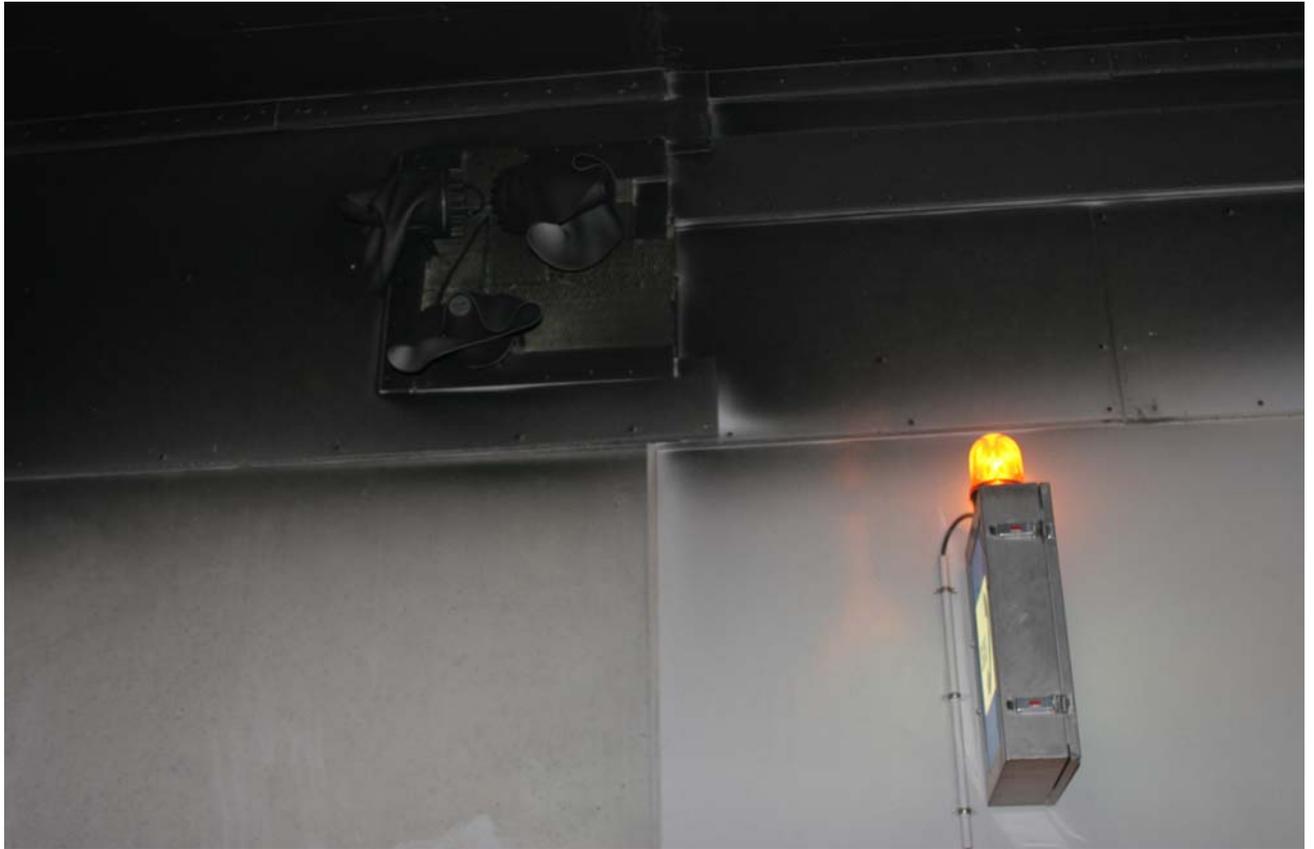
Picture 53: The loud speaker's shell was made of plastic and fixed to the wall near the ceiling where it rapidly melted in the hot smoke layer.

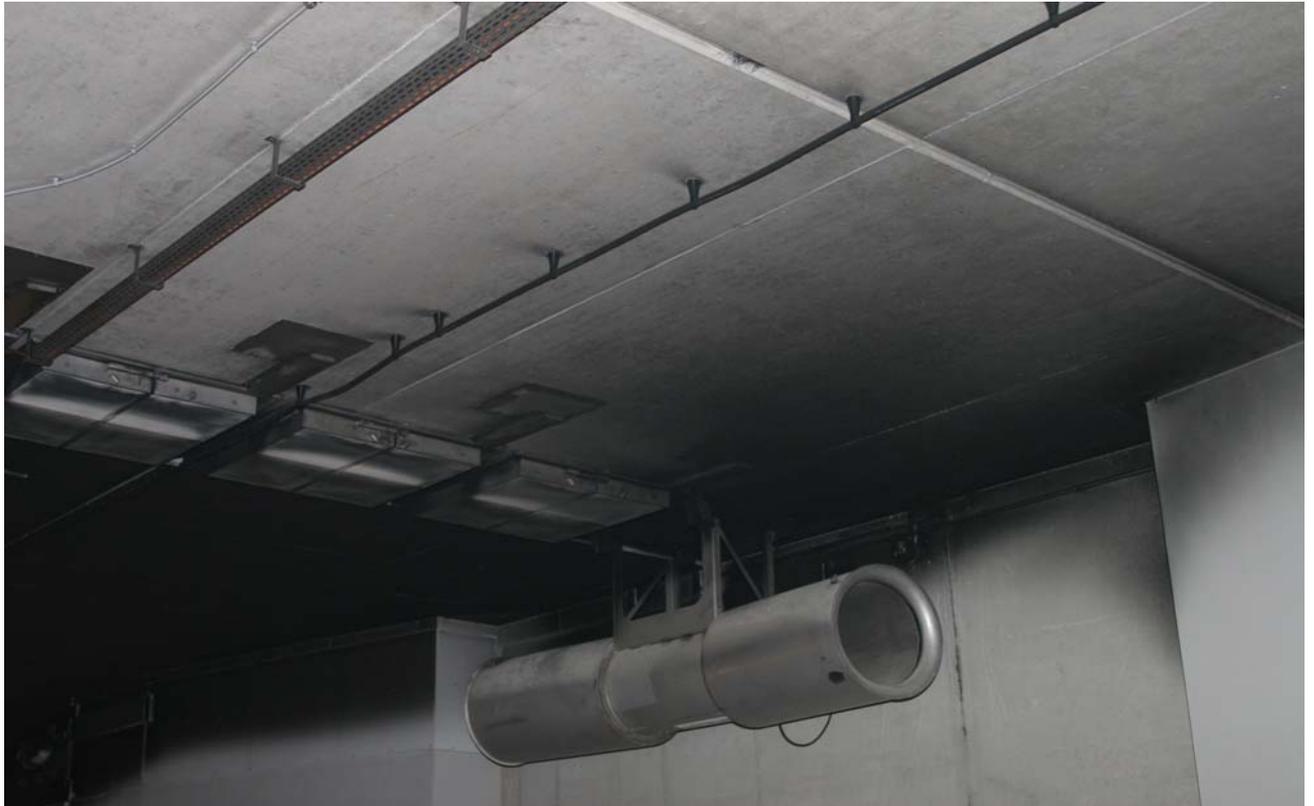
Picture 55: The photo-meter has been installed at the ceiling to detect and activate an early pre-alert in case of fire. So it has been inside of the smoke layer where it was blackened but still well functioning.
