Pictures from a realistic full-scale fire test with two passenger cars and a HRR of 12 MW in the B260 Malberg tunnel at Bad Ems, Germany, on 27th of Sept. 2006

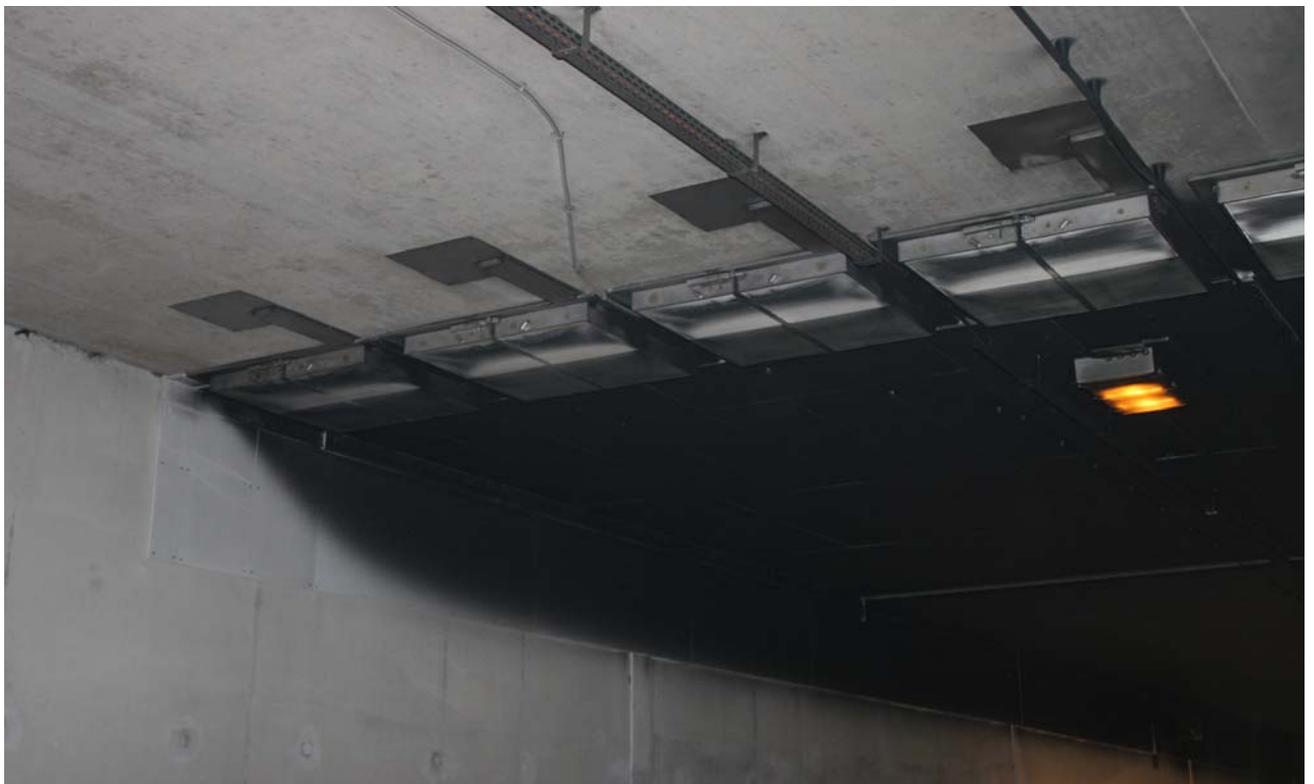
Picture 56: After the test, there was a blackened 1 m high strip to be seen on the northern wall next to the ceiling, extending over 100 m from the smoke extracting station #05 to the next one. During the fire alarm the jet fans in the western division operated in reverse mode without contact to the smoke. However, a small fraction of smoke circulated in the fan niche along the ceiling above the jet fan.
